## Mystery flats near the valve? Maybe not so mysterious!

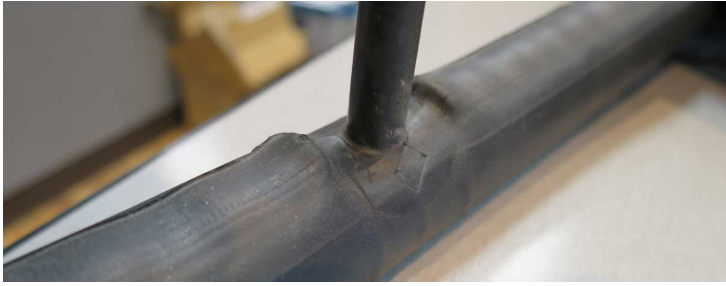
Those two bulging spots near the valve? They are *\*not\** weak spots in the tube! Or at least they weren't weak/defective when installed. Read on.

This particular tube was leaking at one of those bulges. No surprise there; they look scary and the rubber has thinned out. But how? Nothing funny about the rim or tire.

What to do? Make sure you're not pushing the valve up into the tire as you pump! Especially if you're inflating a tube that already has a fair amount of air in it, since pushing it upward under those conditions pretty much guarantees the tube is going to try and bulge in to fill the empty space. --Mike--

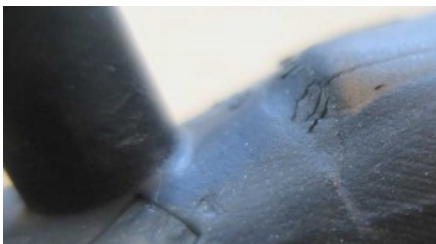
Closeup, showing the lines to the right of the valve, where the tube has developed leaks from being stretched too thin.

Here's how it happened. During inflation, the person pumping up the tube is pushing the tube's valve up into the tire, creating a cavity underneath. As the pressure increases, the tube fills in underneath, bulging downward into that cavity. That's how you get those funny spots either side of the valve. Over time, sometimes not too much time, that thinned-out tube fails. In the smaller photo, you can see what look like small cuts; those are the areas the tube has split and now leaks.
